09/06/85 Midwest Express Airlines, Inc.

Official Accident Report Index Page

Report Number	NTSB/AAR-87/01
Access Number	PB87-910401
Report Title	Midwest Express Airlines, Inc. DC-9-14, N100 ME, General Billy Mitchell Field, Milwaukee, Wisconsin, September 6, 1985
Report Date	February 3, 1987
Organization Name	National Transportation Safety Board Bureau of Accident Investigation Washington, D.C. 20594
WUN	4267-A
Sponsor Name	NATIONAL TRANSPORTATION SAFETY BOARD Washington, D. C. 20594
Report Type	Aircraft Accident Report September 6, 1985
Distribution Status	This document is available through the National Technical Information Service, Springfield, Virginia, 22161
Report Class	UNCLASSIFIED
Pg Class	UNCLASSIFIED
Pages	105
Keywords	removable sleeve spacer; high pressure compressor spacer; improper use of flight controls
Abstract	<p>At 1521 c.d.t. on September 6, 1985, Midwest Express Airlines, Inc., Flight 105, a McDonnell-Douglas DC-9-14 airplane, crashed into an open field at the edge of a wooded area about 1,680 feet southwest of the departure end of runway 19R shortly after taking off from General Billy Mitchell Field, Milwaukee, Wisconsin. The weather was clear with visibility 1

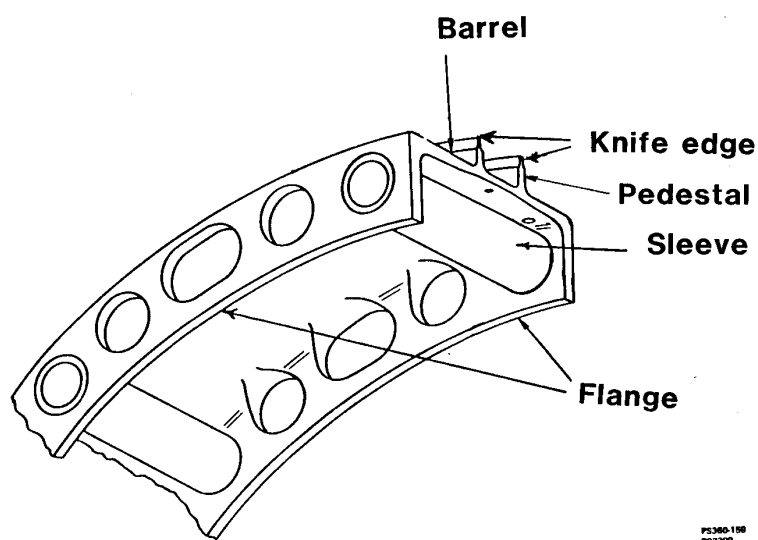
Figure 1.—Main features of a removable sleeve compressor spacer.

control was a lack of crew coordination in response to the emergency. The right engine failed from the rupture of the 9th to 10th stage removable sleeve spacer in the high pressure compressor because of the spacer's vulnerability to cracks.

There was no record of the nature of the previous damage which had necessitated the rework. The specifications regarding airseal blending of the 9-10 spacer allowed machining down to the inside radius, above the pedestal, to a maximum width of 2 inches in one area, or a maximum width of 4 inches for all areas. There is no record of the amount of blending that was performed.

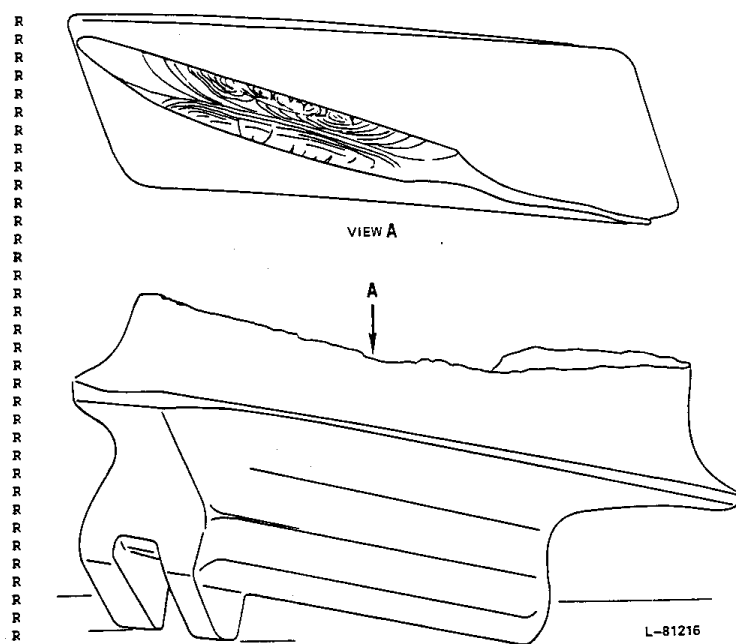
Pratt & Whitney Aircraft
JT8D ENGINE MANUAL (PN 481672 - RESTRUCTURED)
COMPRESSOR BLADES, STAGE 9 - INSPECTION-01

1. Blade fractures and airfoil cracks.
2. The following information specifically applies to engines which have been removed due to stalls, but also should be followed as a general inspection.
3. Evidence of fracture of cracking in either 8th or 9th stage blades is justification to scrap all blades of both stages.
 - a. Inspect for fractures originating in airfoil just above root platform (Figure 801). Such fractures without evidence of foreign object damage and exhibiting multiple origins on fracture surface as shown in View A in Figure 801, indicate excessive blade airfoil stress. Because of this severe stress environment and resultant loss in material strength, remaining 8th and 9th stage blades should be scrapped when this condition is observed.

b. Inspect blade airfoils for cracking in area just above platform. Any blade exhibiting cracking in this area also indicates excessive blade stress. See Figure 802. Remaining 8th and 9th stage blades should be scrapped regardless of whether or not they exhibit cracking.
